# ALASKA STYMIES STUDED TIRES

by Tom Kuennen

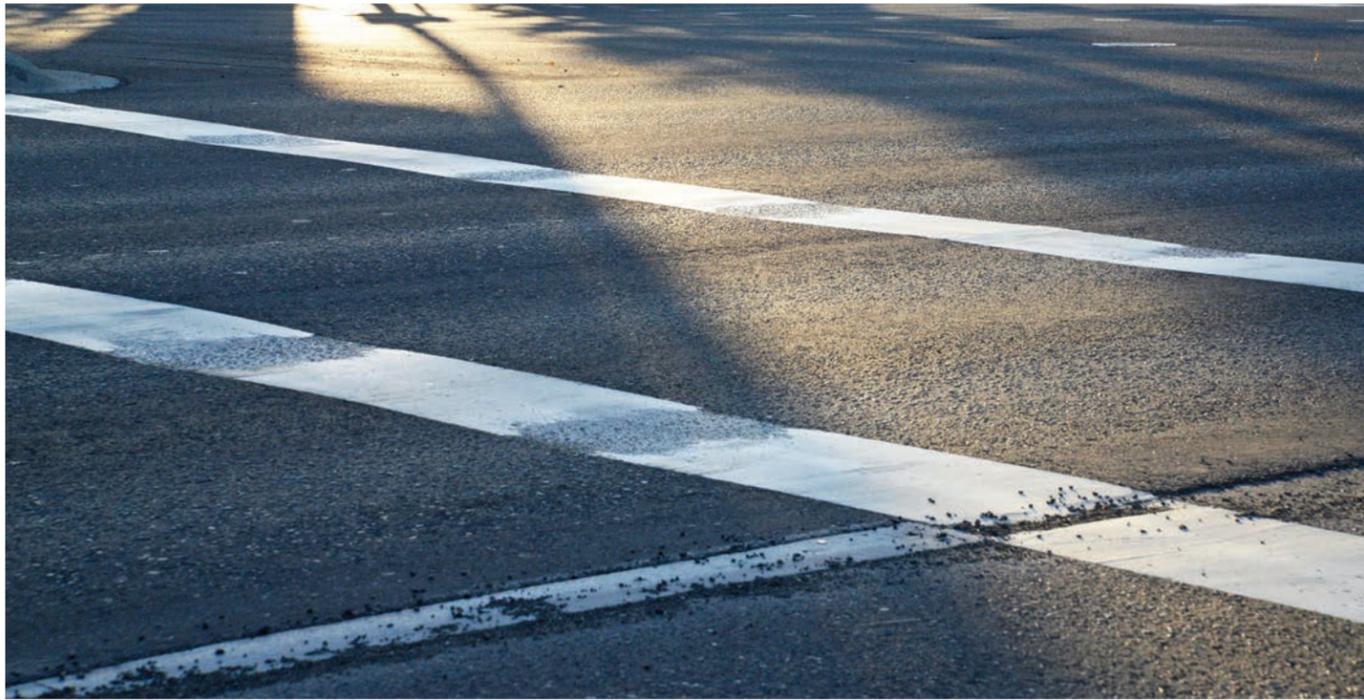
Undulating transverse shadows across rutted pavement -- and gouged intersection striping -- shows rut damage caused by studded tires on Minnesota Avenue in Anchorage

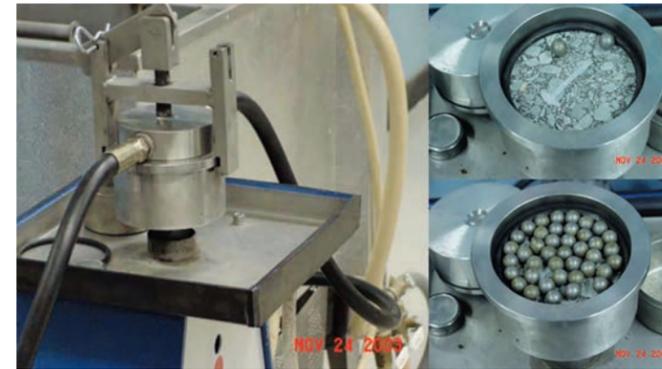
Alaska DOT&PF's Prall tester for studded tire damage

Lab tests confirm these performance properties, Kluttz says. The Prall test, Alaska Test Method 420, for studded tire damage was originally developed in the Nordic countries and is standardized as EN12697-16 in the European Committee for Standardization (hence the standard SI units). Test specimens are 100. mm (3.9 in.) in diameter and 30. mm (1.2 in.) thick and are tested at 5 °C (41 °F). The specimen is loaded in the test device and covered with 40 stainless steel spheres 12 mm (0.47 in.) in diameter. The test chamber is oscillated with a stroke of 43 mm (1.7 in.) at a frequency of 950 strikes per minute for a period of 15 minutes.

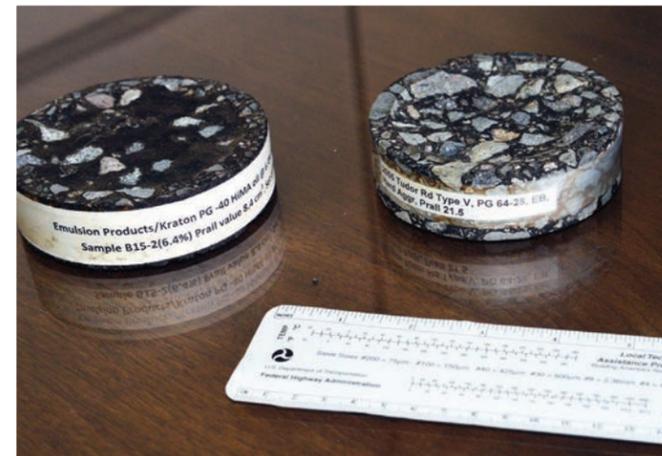
The standard Prall test specimen on the right shows typical abrasion with most of the aggregate clearly visible. The Prall test steel spheres progressively wear the binder and fine aggregate from the specimen surface. With the PG-40 HiMA binder specimen at left, much less of the surface is abraded due to its resilience, thus it can continue to protect the aggregate below from fracture

"What we saw with Prall testing was that the conventional material core sample has a lot of material removed," Kluttz says. "Large aggregate is pretty much all you see. The studs pick out small aggregate and binder, expose the large aggregate, and eventually that fractures and comes out. Then very quickly, the studs pick out more asphalt and fines in mastic."

"But with the HiMA sample, what you see is mostly asphalt," he says. "The test picked out some of the mastic and some of the large aggregate, but what remains is exposed asphalt that is just tougher. It's tough enough to resist being picked up by the studs."

The wheel paths look dark much like the Prall test specimens, indicating that roughly the same behavior is occurring in the laboratory and in the field. The Alaska DOT&PF is pleased with the performance and is specifying more projects with modified PG 64-40 E binder and hard aggregates, designated as Hot Mix Asphalt, Type VH by Alaska DOT&PF.

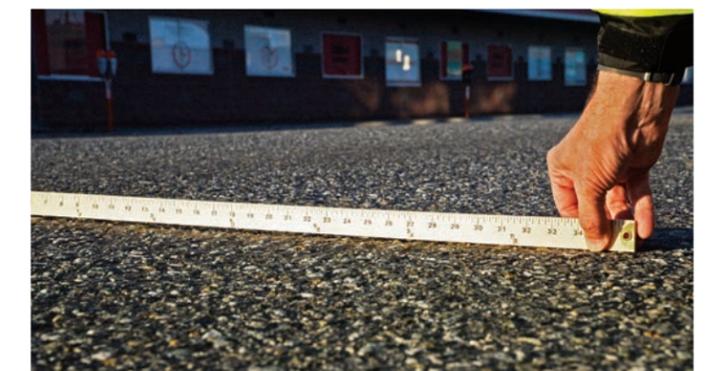
After four winter seasons (2015-2019), 200 block of E 5th Avenue with HiMA-modified PG 64-40 E binder shows minimal rutting

To date, performance has been good with minimal damage caused by studded tire wear or traffic loads. In 2019, after four years of traffic including studded tires, the average rut depths were 0.204 in. (5.2 mm) on 5th Avenue and 0.198 in. (5.0 mm) on 6th Avenue in downtown Anchorage.
